Investigation of the stress corrosion cracking
susceptibility of annealed and heat treated
alloy 625 castings and forgings in sea water

INVESTIGATION OF THE STRESS CORROSION CRACKING
SUSCEPTIBILITY OF ANNEALED AND HEAT TREATED
ALLOY 625 CASTINGS AND FORGINGS IN SEA WATER

OCEAN ENGINEERING - COURSE XIIIA

JUNE, 1987

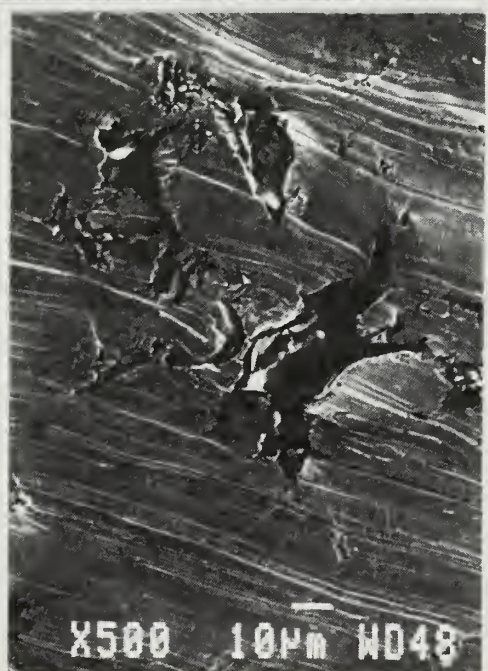
Figure 25 Photomicrographs of "Forged/Annealed" Alloy 625
 Elongated Gage Length for +1.0 and -1.0 Volts
 Test Conditions - Specimens 81 and 83
